## Duplex Stainless Steel of Type UNS S32101 and Ferritic Stainless Steel of Type AISI 430 Subjected To Cathodic Hydrogenation

This work presents a study on the duplex stainless steel UNS S32101 and ferritic AISI 430 when subjected to cathodic hydrogenation, to ascertain their behavior under the action of hydrogen. Throughout the research, with the aid of optical (MO), scanning electronics (SEM) and atomic force (AFM) microscopy, both hydrogen embrittlement and pitting corrosion after hydrogenation and degassing in UNS S32101 duplex stainless steel became evident. Subsequently, the X-ray diffraction performed to verify the phase transformations confirmed the transformation of the austenitic phase into the martensitic phase in the duplex steel and confirmed the formation of Cr<sub>23</sub>C<sub>6</sub> precipitates in the ferritic steel. And so, it corroborated with the SEM images, proving the transformation of  $\sigma$ -phase agent of pitting corrosion in duplex steel.

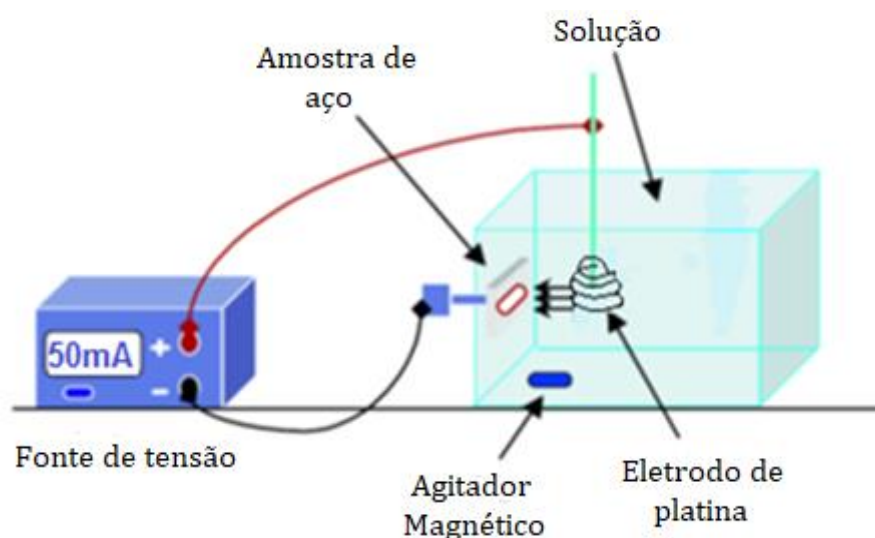
*Figure 1: Schematic of the hydrogenation process. Source: The author.*

The solution was prepared as follows: dilution of 1g of As<sub>2</sub>O<sub>3</sub> in 1L of distilled water at 80 ° C. The hydrogenation solution: consisted of diluting 100 ml of the arsenic trioxide solution in a 0.5 mol L<sup>-1</sup> solution of H<sub>2</sub>SO<sub>4</sub>. 27ml of H<sub>2</sub>SO<sub>4</sub> was applied in 1 liter of solution. In this solution, arsenic trioxide was applied to avoid the loss of hydrogen to the atmosphere. A platinum anode and a current density of 1000 A/m<sup>2</sup> were used. Figure 1 shows a representative diagram of the hydrogenation process.

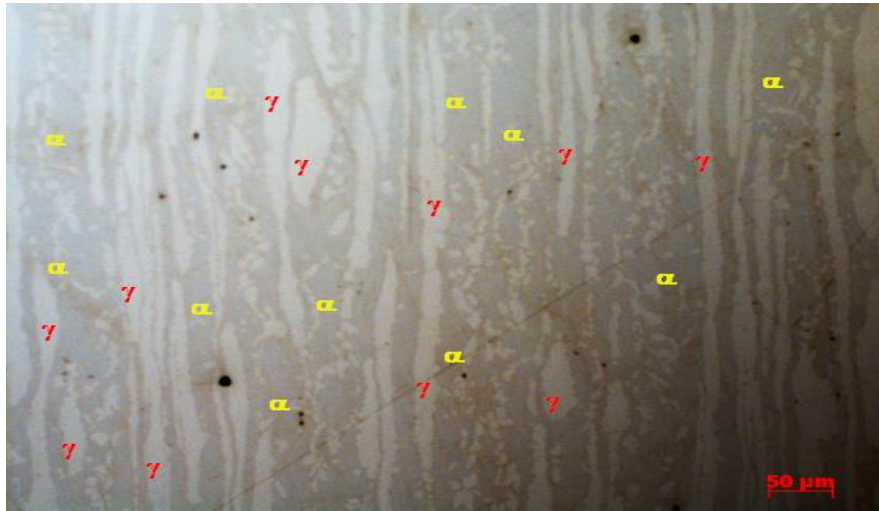
**Figure 2: optical microscopy image of sanded, polished UNS S32101 duplex stainless steel, with Murakami attack to reveal austenitic (□) and ferritic (□) grains, with 200x magnification.**

Figures 2 and 3 are optical micrographs of the UNS S32101 duplex stainless steel. Figure 2 of this steel is only sanded, polished and attacked (Murakami) to reveal the ferritic ( $\square$ ) and austenitic ( $\square$ ) grains. Figure 3 is of the UNS S32101 duplex stainless steel sanded, polished, hydrogenated for 4 hours and degassed for a week.

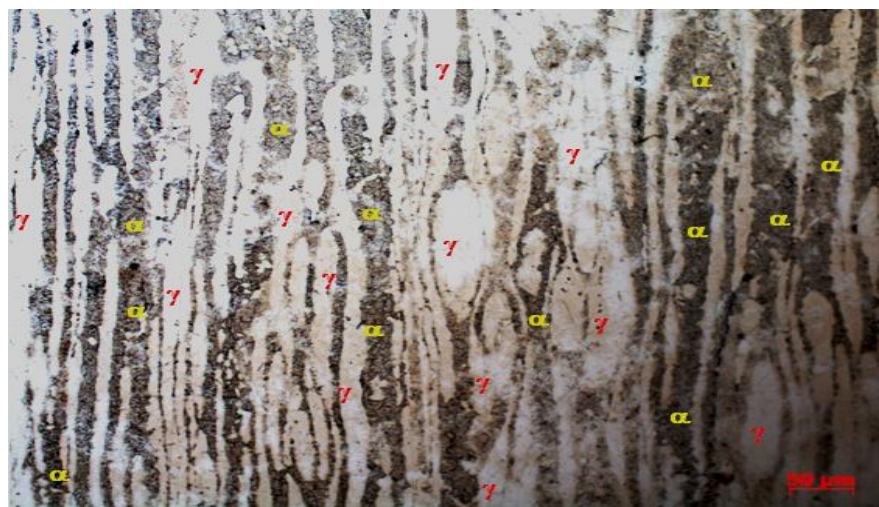
**Figure 3: optical microscopy image of UNS S32101 duplex stainless steel sanded, polished, hydrogenated for 4h and degassed for 7 days, with a 200x magnification.**

In figure 3 the difference was noted, as the ferritic grains appear darker, showing the damage caused by the entry and exit of hydrogen in the steel. In order to know an explanation capable of elucidating the destruction caused by hydrogen in the ferritic grains, the samples of the ferritic stainless steel AISI 430 were hydrogenated and analyzed. Figure 4 is an optical microscopy image of 430 ferritic stainless steel just sanded and polished. Figure 5 is an optical microscopy of ferritic stainless steel 430 after hydrogenation for 30 min and degassing for one week. In this it is possible to see that the surface was damaged after the insertion and disinsertion of the hydrogen. Note the appearance of innumerable cavities, as if the hydrogen transformed the ferrite into precipitates and those on the surface were detached, showing only the cavity at the site.

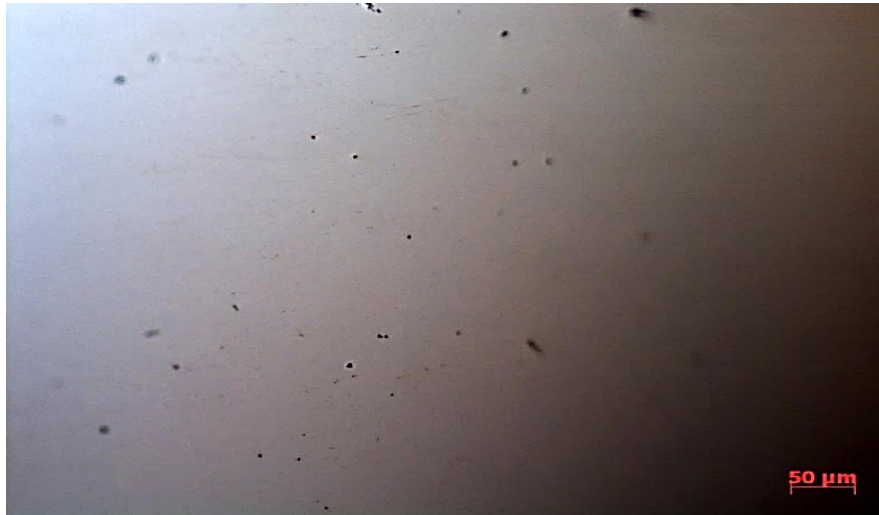
**Figure 4:** optical microscopy image of sanded and polished AISI 430 ferritic stainless steel, with a 200x magnification.

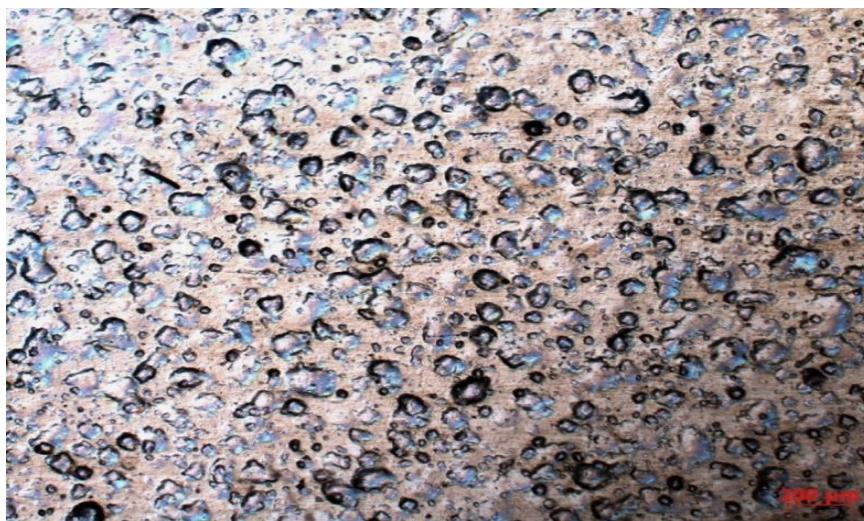
**Figure 5:** optical microscopy image of sanded, polished, polished, hydrogenated AISI 430 stainless steel for 30 min and degassed for 7 days, with a 200x magnification.

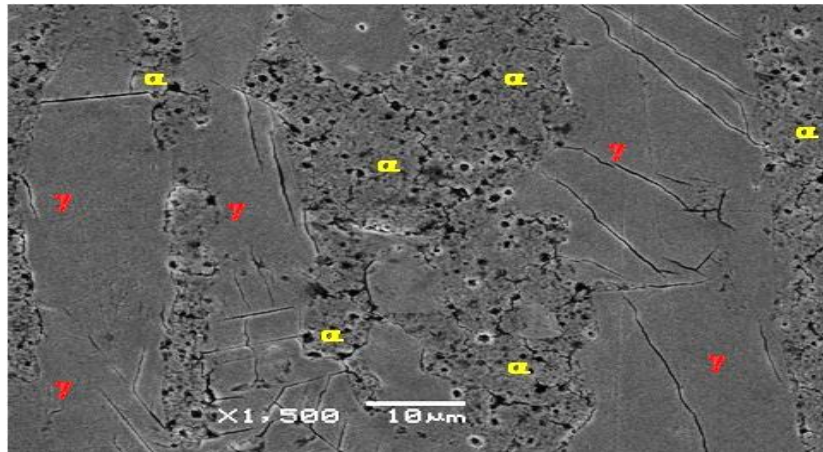
*Figure 6: Scanning electron microscopy image of UNS S32101 duplex stainless steel sanded, polished, hydrogenated for 4 hours and degassed for 7 days, with a 1500x magnification.*

Due to the limitations of optical microscopy, scanning electron microscopy images were sought to better clarify the damage caused by the entry and exit of hydrogen from the material. Thus, figures 6 and 7 are SEM images of duplex stainless steel of the type UNS S32101 hydrogenated for 4h and degassed for a week. With greater/magnifications, as in the micrographs shown in figures 6 and 7, the microcracks in the austenitic and ferritic grains became evident, in addition to localized corrosion, in the form of pitting corrosion in the ferritic grains. Since, this corrosion is characterized by pits that are formed in the material, and these normally penetrate the interior of the metal from the surface. This type of corrosion is common to go unnoticed, because very often, it is not detected until the failure occurs. Figures 8 and 9 are SEM images of ferritic stainless steel of the AISI 430 type. In figure 8, with a 300x magnification, there are some cracks inside the cavities left at the outlet of the hydrogen. Figure 9 is an enlargement - 1500 x - of this area, making it possible to observe that they are really cracks within the cavity. In this way, it is demonstrated that there is the formation of precipitates and that the hydrogen that is below these precipitates to leave the metal, pushes them, detaching them from the material and thus, not only leaving a cavity, but also cracks within them.

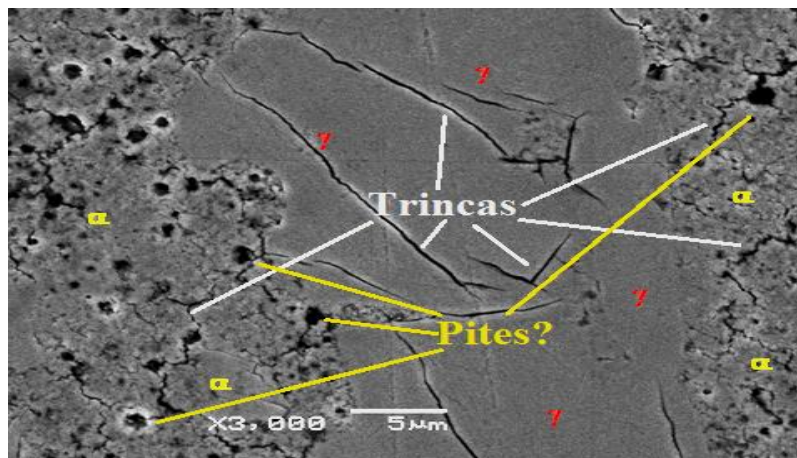
*Figure 7: scanning electron microscopy image of UNS S32101 duplex stainless steel sanded, polished, hydrogenated for 4 hours and degassed for 7 days, with a 3000x magnification.*

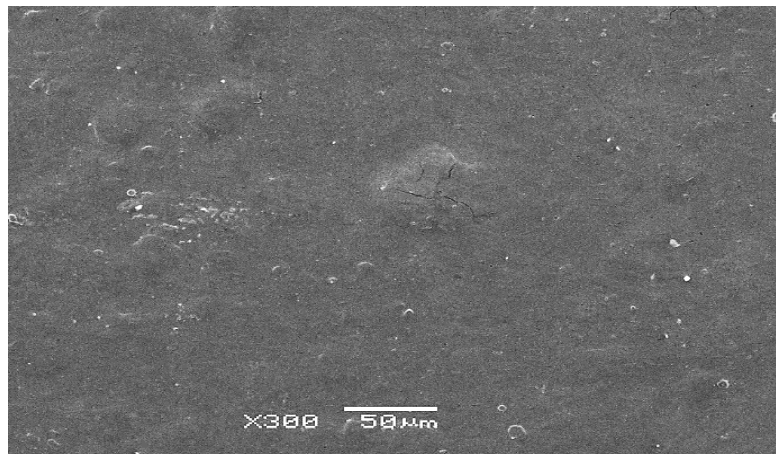
*Figure 8: scanning electron microscopy image of sanded, polished, polished, hydrogenated AISI 430 ferritic stainless steel for 30 min and degassed for 7 days, with a 300x magnification.*

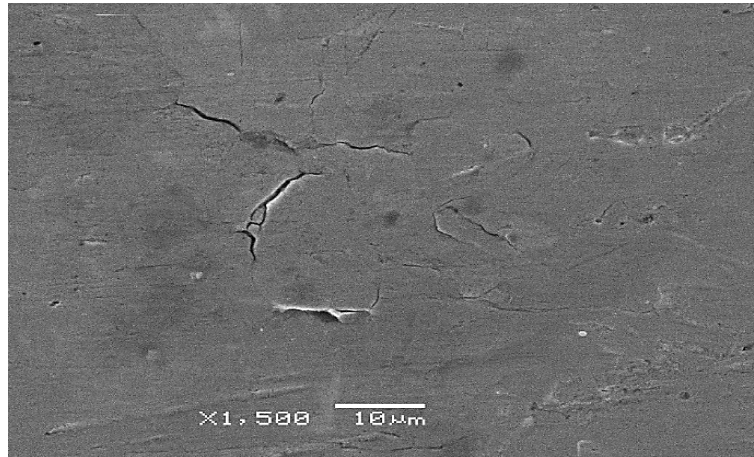
**Figure 9: scanning electron microscopy image of sanded, polished, polished, hydrogenated AISI 430 ferritic stainless steel for 30 min and degassed for 7 days, with a 300x magnification.**

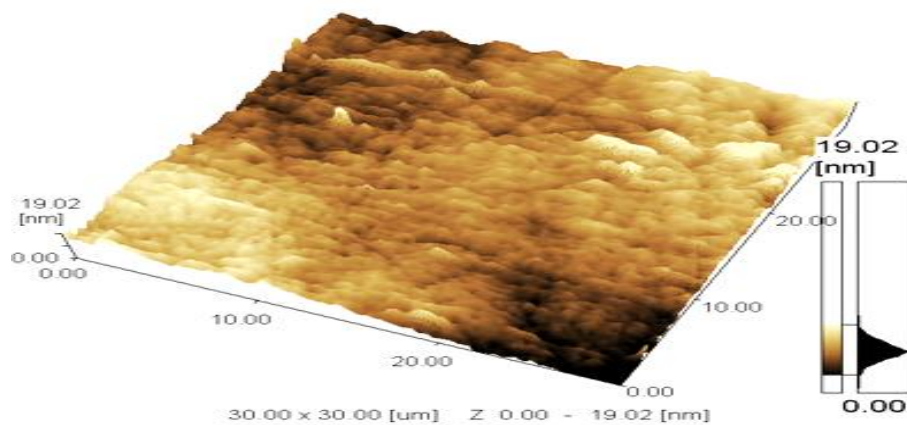
**Figure 10: Depth profile in duplex stainless steel type SAF2101L without hydrogenation.**

The atomic force microscopy technique was used to verify the depth of cracks and pits that were generated after hydrogenation in the UNS S32101 duplex stainless steel. Figure 10 shows the atomic force microscopy image of UNS S32101 duplex stainless steel without hydrogenation, only polished. In this, it is possible to observe that the variation of the superficial relief is around 19 nanometers for the deepest regions. Figure 11 is a micrograph of the same steel, hydrogenated for four hours and degassed for seven days. This image is of the cracked region, showing that the crack depth is approximately 277 nm, as the darker parts in the figures represent deeper regions in the structure, in this case the cracks, and the lighter parts represent slightly higher regions, demonstrating the fact that the cracks detach part of the material in the form of a surface detachment. The depth of the pitch around 136 nm can be seen in the atomic force microscopy image in figure 12.

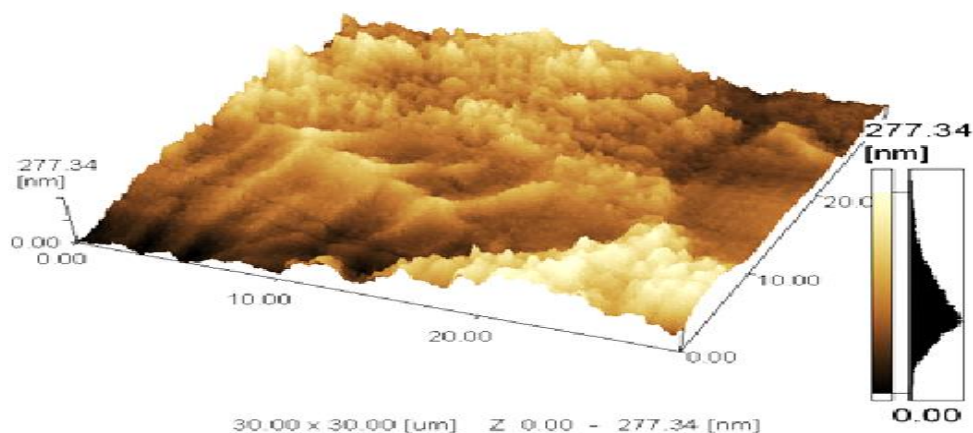
**Figure 11: Crack depth profile in duplex stainless steel type SAF2101L hydrogenated for 4h and degassed for 7 days.**

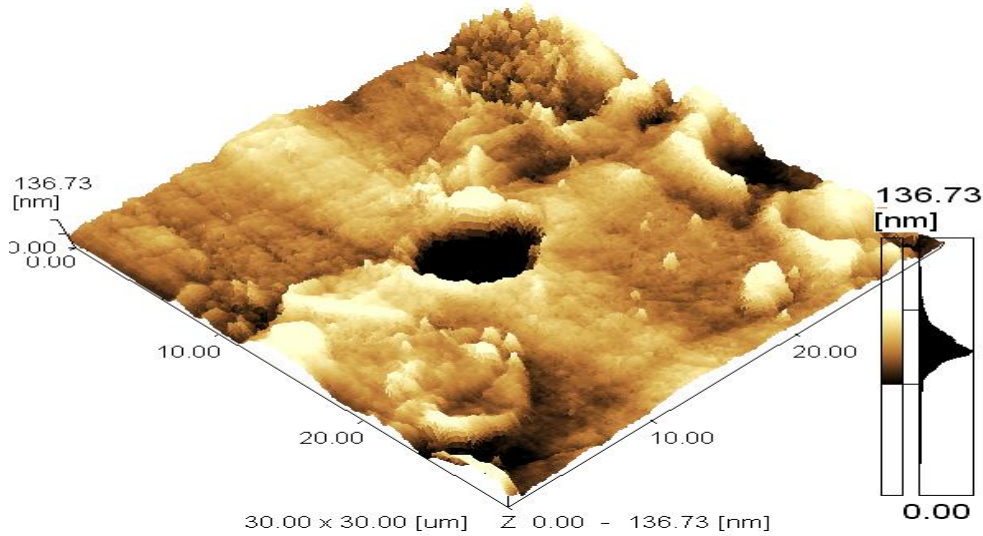
**Figure 12: Pite depth profile in duplex stainless steel type SAF2101L hydrogenated for 4h and degassed for 7 days.**

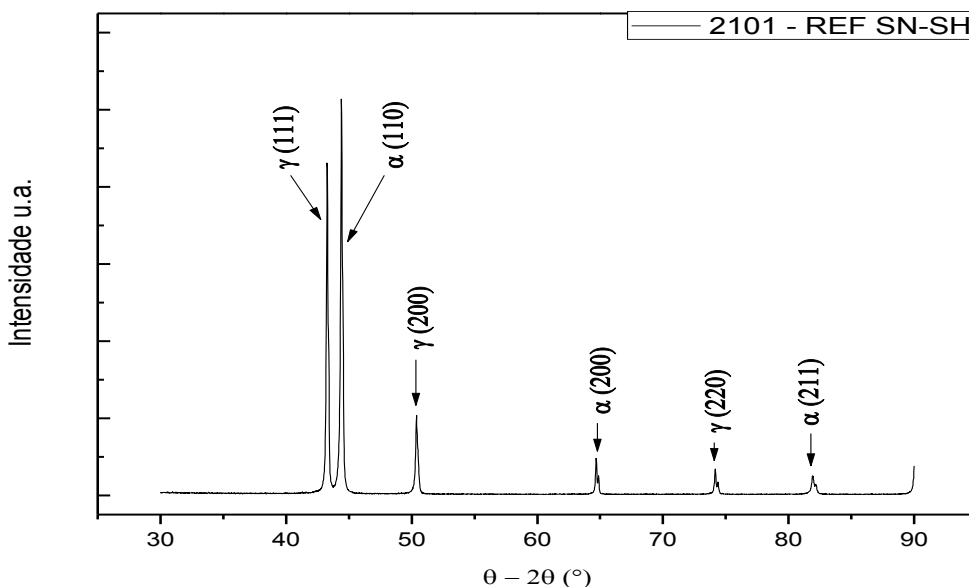
Graph (1) is the X-ray diffractogram of UNS S32101 duplex stainless steel without hydrogenation, showing the peaks of phases  $\gamma$  and  $\alpha$  present in the steel.

The phases and phase transformations, which occurred with the entry and exit of hydrogen in the material, were investigated by X-ray diffraction [4,6,9,14,16]. Once, in austenitic steels, degassing is an important part of this process [17]. In the samples of stainless steel of type UNS S32101 before hydrogenation, the phases  $\gamma$  and  $\alpha$  only were confirmed, as seen in graph (1). After hydrogenation, a diffractogram was performed after seven days of degassing, graph (2), showing  $\gamma$  phase peaks as well as a peak at approximately  $46.18^\circ$ . The transformation from  $\gamma$  phase  $\alpha'$  (transformation from austenite to martensite:  $\gamma \rightarrow \epsilon \rightarrow \alpha'$ ) was expected, due to the approximately 50% percentage of austenitic phase in the UNS S32101 duplex stainless steel [4,6,14,18,19]. Phase  $\sigma$  is a stacking fault that arises during hydrogenation. Over time this phase  $\sigma$  would turn into martensite  $\alpha'$ . However, according to the literature, the  $\alpha'$  peak is approximately  $45.95^\circ$  and the  $\sigma$  peak is approximately  $48^\circ$ , which does not fit with the peak shown in the diffractograms of hydrogenated UNS S32101 duplex stainless steel samples, as this is at  $46.18^\circ$ . This peak coincides with the sigma phase peak ( $\sigma$ ) [20,21]. The graph (3) is a comparison of graphs (1) and (2), that is, it is the UNS S32101 duplex stainless steel without hydrogenation and hydrogenated for 4h, and degassed for seven days, in this it is possible to see clearly the phase transformation of this steel after the entry and exit of hydrogen.

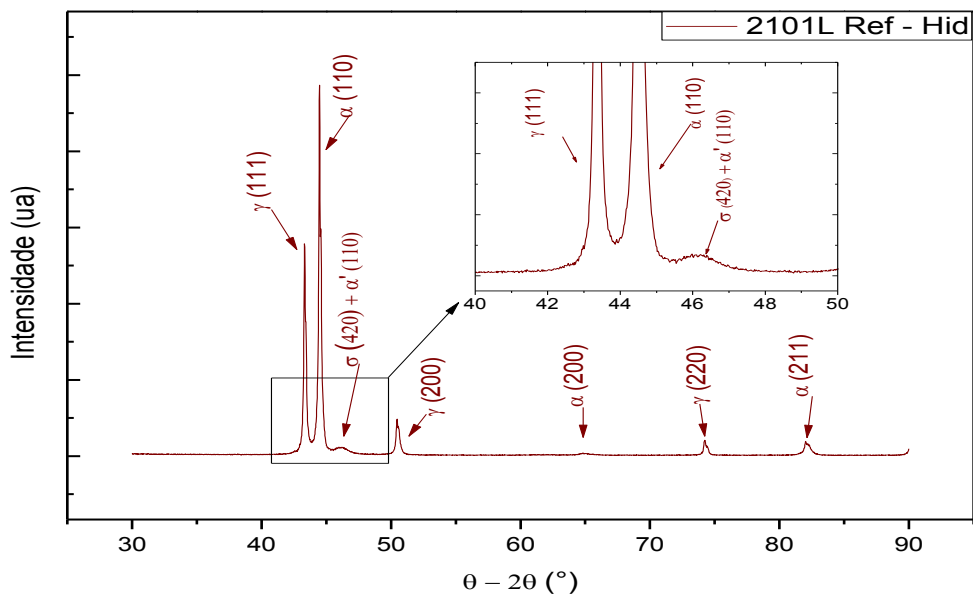
Graph (2) is the X-ray diffractogram of UNS S32101 duplex stainless steel, hydrogenated for 4h, after seven days of degassing, showing the peaks of phases  $\gamma$ ,  $\alpha$  and possibly  $\sigma$  and  $\alpha'$  present in the steel.

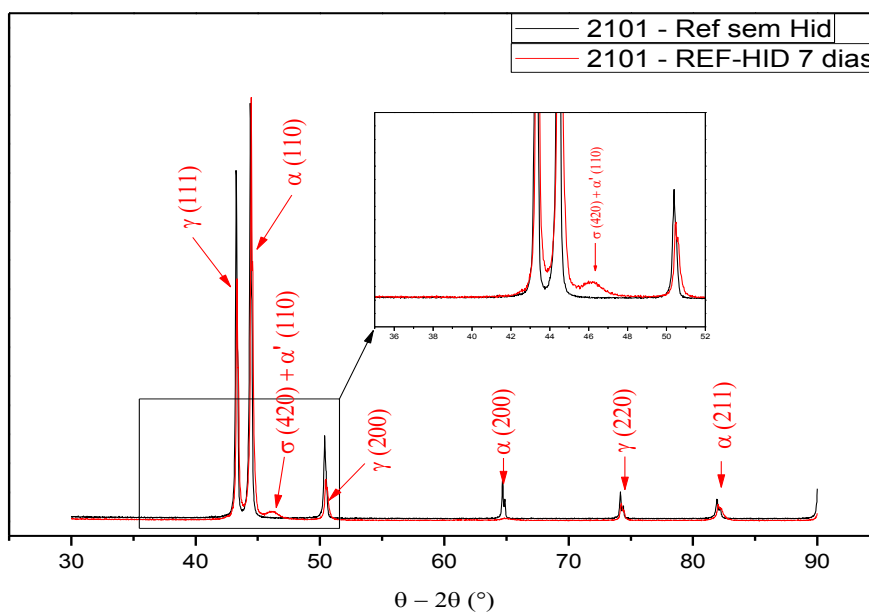
Graph (3) is the X-ray diffractogram of UNS S32101 duplex stainless steel without hydrogenation and hydrogenated for 4 hours, after seven days of degassing, showing the peaks of phases  $\gamma$ ,  $\alpha$  and possibly  $\sigma$  and  $\alpha'$  present on steel.

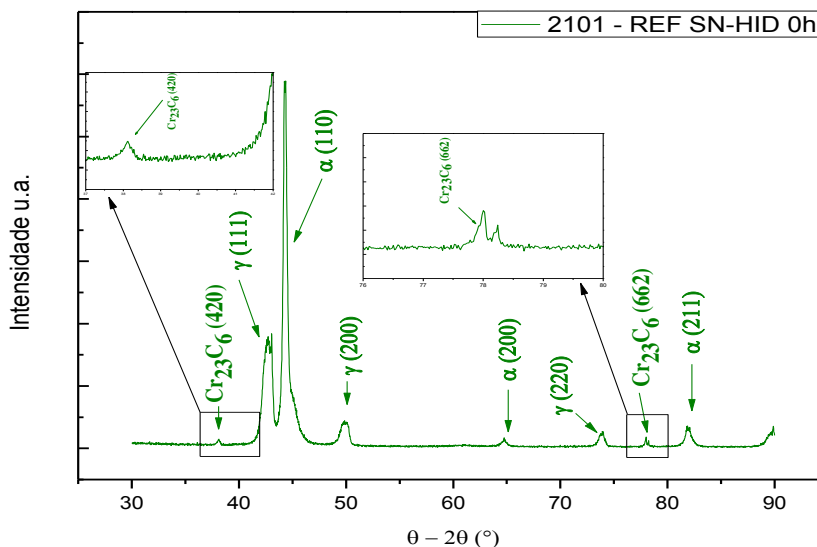
Graph (4) is the X-ray diffractogram of duplex stainless steel, type SAF2101, right after 4h hydrogenation (zero hours of degassing), showing the peaks of the phases present in the steel.

Therefore, a more detailed analysis was necessary and thus, diffractograms of the kinetics of the hydrogen action in the phase transformation of the duplex stainless steel of the UNS S32101 type were made. In graph (4), the peaks of the phases present can be seen immediately after hydrogenation, that is, with 0h of degassing. In this graph, the peaks of the  $\sigma$  and  $\alpha'$  phases are seen to be wider, probably due to the presence of hydrogen that did not detach from the material in time. Also noted is the presence of two new peaks, one at approximately  $38^\circ$  and the other at  $78^\circ$ , which are identified as precipitates of the Cr<sub>23</sub>C<sub>6</sub> type [1]. According to Chen and Yang [21] this induces the formation of the  $\sigma$ -phase in the grain boundaries of the ferrite instead of the formation being in the grain boundaries of the austenite. The high rate of interfacial

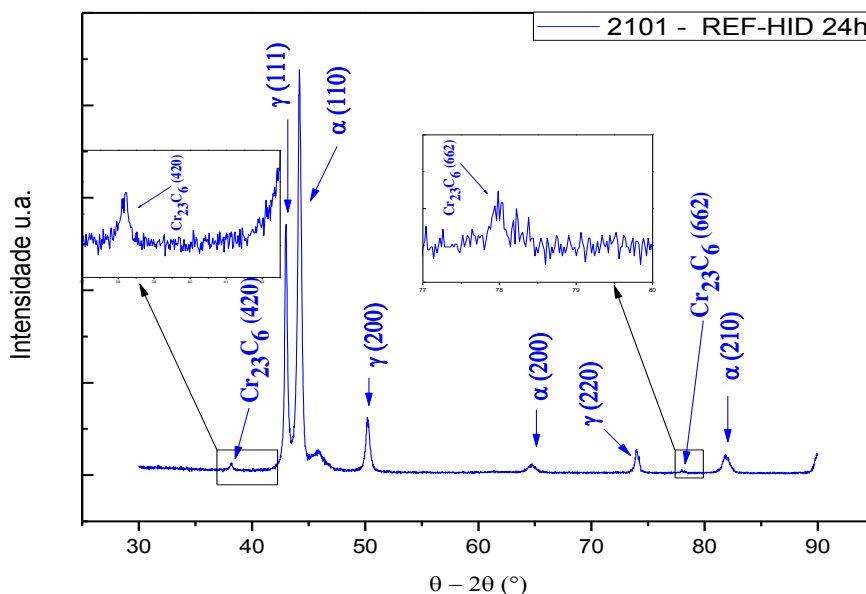
Graph (5) is the X-ray diffractogram of duplex stainless steel, type SAF2101, after 4h hydrogenation (twenty-four hours of degassing), showing the peaks of the phases present in the steel.

A new analysis was made after 24h of degassing to verify the present phases, see graph (5). In this diffractogram it is noted that the peaks are no longer widened, possibly due to the evasion of hydrogen from the material, the peaks are still observed at 38° and 78°, however with less intensity, since the peak that was before 46.18° changes to approximately 45.97°. Thus, it can be understood that the material is in an unstable situation. However, looking at graph (6), when diffractometry is performed again with 7 days of degassing, the peak at 46.18° is again noted and the peaks at 38° and 78° disappear, showing that the situation of instability ended.

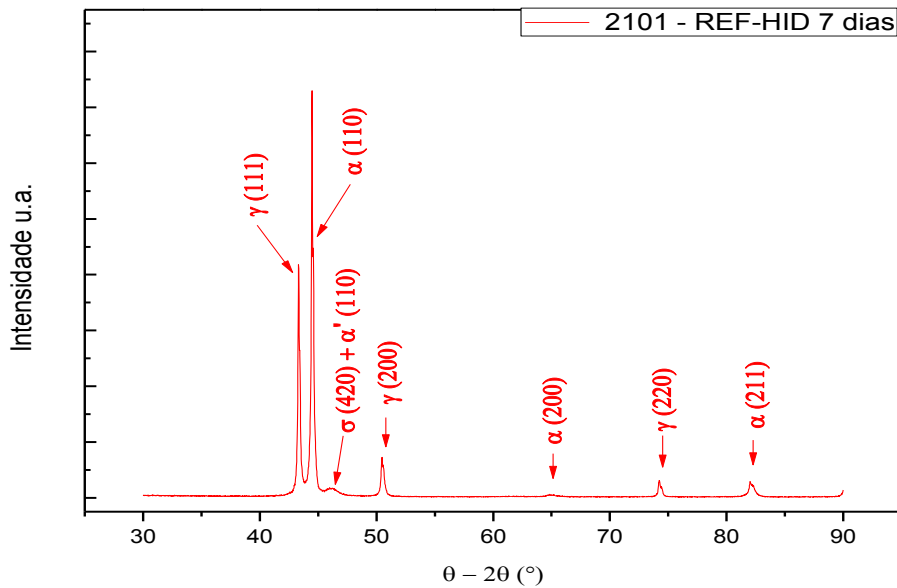
Graph (6) is the X-ray diffractogram of the duplex stainless steel type SAF2101, after hydrogenation for 4 hours (seven days of degassing), showing the peaks of the phases present in the steel.

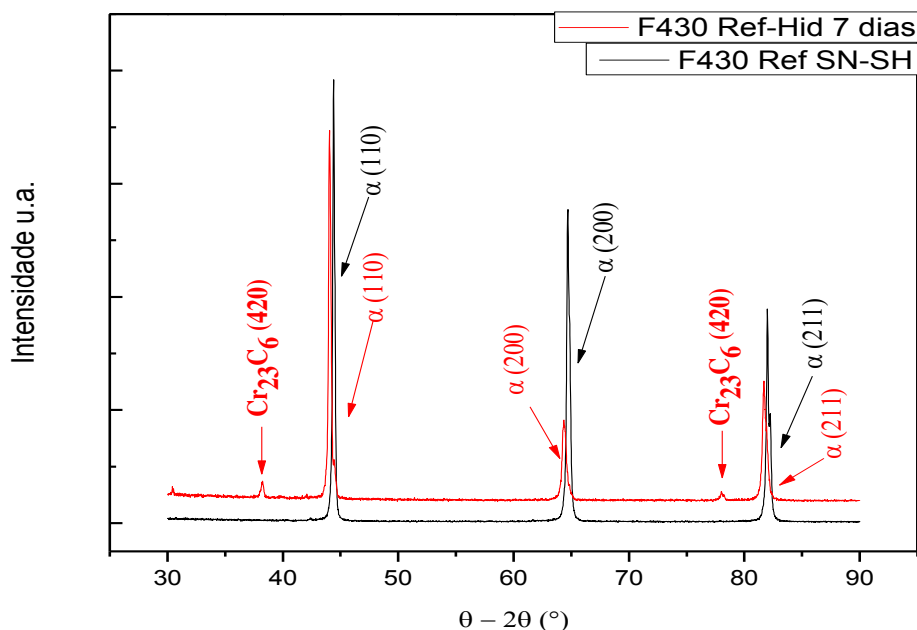
Graph 7: X-ray diffractogram of ferritic stainless steel of type AISI 430 without hydrogenation and hydrogenated for 30 min, after seven days of degassing, showing the peaks of the phases present in the steel.

The X-ray diffractograms of ferritic stainless steel of the AISI 430 type are shown in graph 7. In this, the black curve shows the AISI 430 stainless steel only sanded, polished and without hydrogenation, highlighting only the  $\alpha$  ferrite peaks. The red curve is the X-ray diffractogram of the ferritic stainless steel AISI 430 hydrogenated for 30 min and degassed for 7 days. In this it is possible to see the ferrite peaks  $\alpha$  as well as two new peaks: one at approximately  $38^\circ$  ( $38^\circ 12'$ ) and another close to  $78^\circ$  ( $78^\circ 15'$ ). These peaks coincide with the peaks of  $\text{Cr}_{23}\text{C}_6$  type precipitates identified by Mei and Guimarães [1].
