A case report:-Ovary penetration by a Multiload-Cu 375 intrauterine contraceptive device.

Bariha Kalpana, Chaturvedi Hina, Sharma Anju, Beniwal Devendra, Mehta Nidhi, Agrawal Megha, Kurre Amarawatin

Sawai Mansingh Medical College Jaipur, Rajasthan

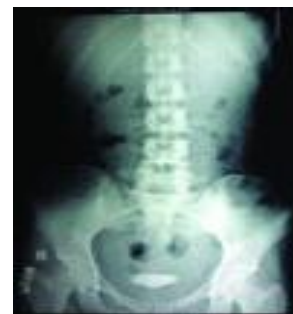
Fig-1 The patient had a soft abdomen, with regular bowel habits. Her per-rectal examination was normal. An X-ray of her abdomen revealed that the copper-T was in the left side of her abdomen

A plain radiograph of the abdomen is usually the initial examination of choice, for verifying the presence of an IUCD in the pelvis. Once it is found, an ultrasound examination can be done to determine the location of the IUCD which is relative to the uterus. The treatment of the misplaced IUCD is surgical, either laparoscopy or laparotomy. Withdrawal of the migrated IUCD is advisable even if its migration has not given rise to any clinical symptoms [8], so that further complications like a bowel and bladder perforation or a fistula formation may be averted.
